Manhole Inspection Summary

Manhole # S71Q__002MH

Location Address: **6721 Danville Ave.**

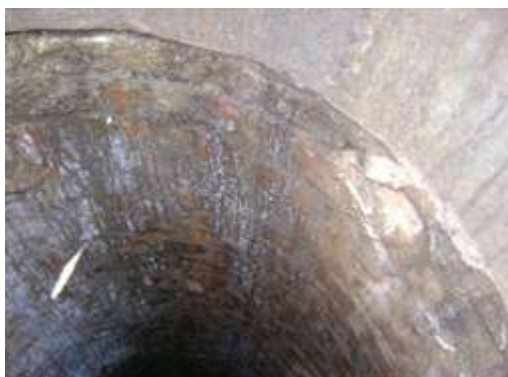
Defect 4

Infiltration: ☐ None ☒ **Joint** ☐ Cracks ☒ **Mortar** ☐ Roots ☐ Wall

Infiltration-mortar joints-chimney

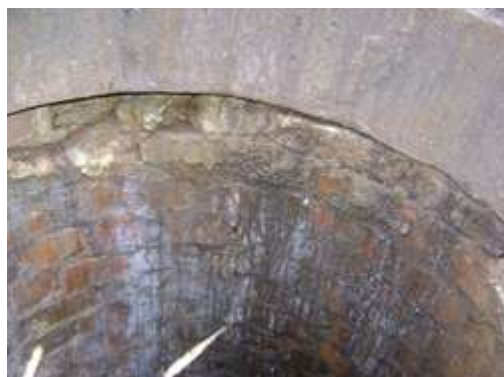
Defect 3

Condition: ☐ Sound ☐ Cracked ☐ Root Intrusion ☒ **Loose Brick** ☒ **Deteriorated**

Deterioration-chimney

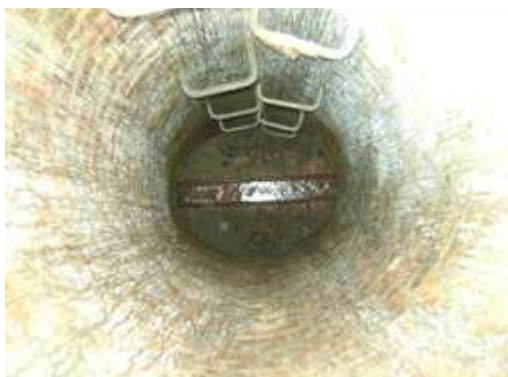
Defect 1

Infiltration-running down wall from chimney

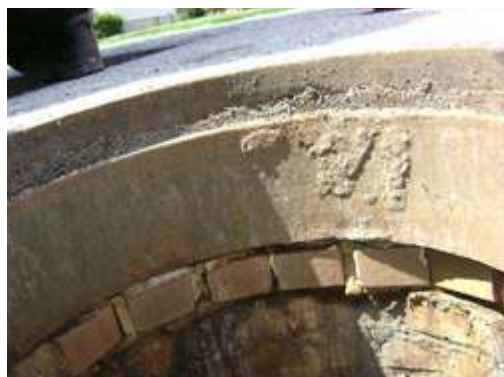
Defect 2

Loose Bricks-chimney

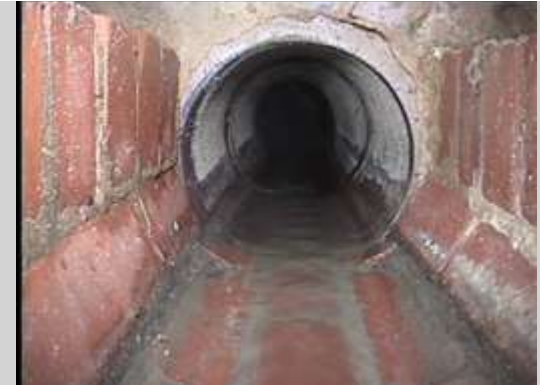
12 O'Clock Outflow

8 in. Circular Gravity Sewer
Pipe Out @ 12 O'Clock

Pipe Height: **8.4** (in.) Rod and Bar (Angled)
Pipe Material: **Clay** ☐ Pipe Lined
Invert Depth: **13.92** (ft.) Flow Characteristics: **Slow**
Deposits: ☒ None ☐ Mud ☐ Sludge ☐ Debris ☐ Grease
Silt Depth: (in.) Deposits Extent:
Infiltration: **None** Pipe Seal Cond: **Sound**

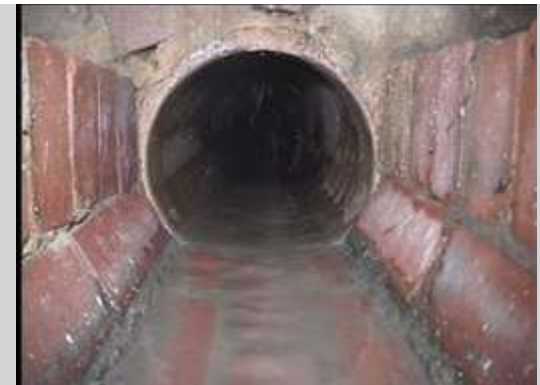
6 O'Clock Inflow

8 in. Circular Gravity Sewer
Pipe In @ 6 O'Clock

Pipe Height: **8.4** (in.) Rod and Bar (Angled)
Pipe Material: **Clay** ☐ Pipe Lined
Invert Depth: **13.67** (ft.) Flow Characteristics: **Slow**
Deposits: ☒ None ☐ Mud ☐ Sludge ☐ Debris ☐ Grease
Silt Depth: (in.) Deposits Extent:
Infiltration: **None** Pipe Seal Cond: **Sound**
